Belvac Production Machinery Technical Bulletin

ISSUE 6, VOLUME 12, JUNE 2009

CC93/CC95 Trimmer Rotary Union Replacement

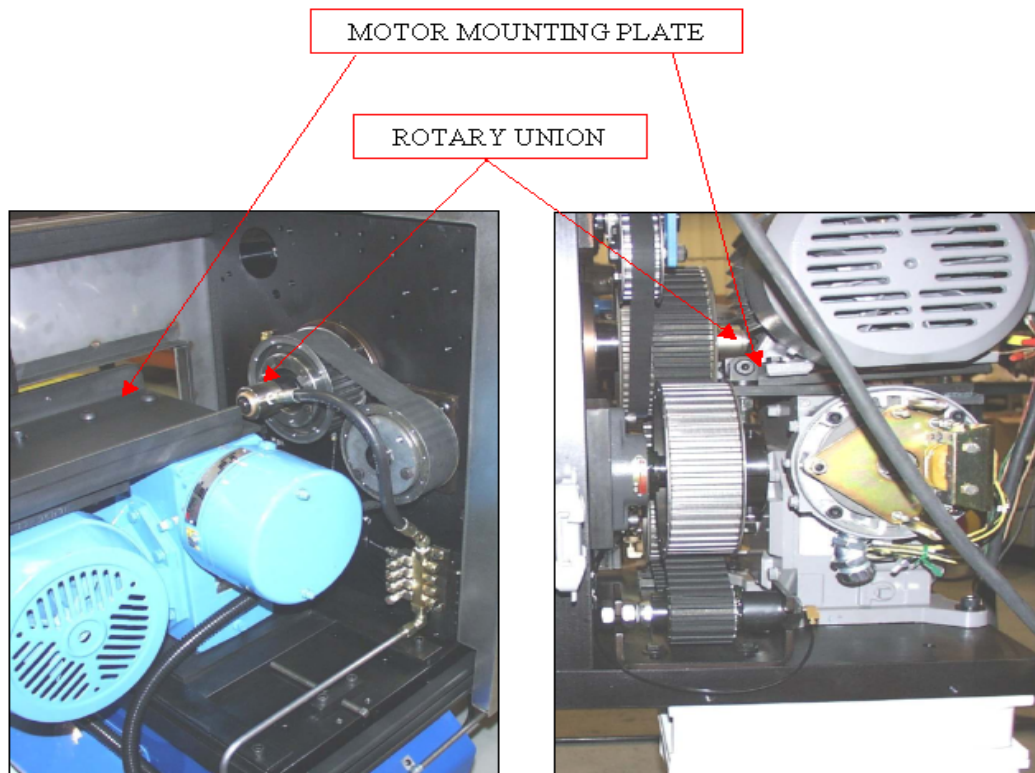
The new rotary union has a slightly larger body size than the part it replaces. Please note when installing for the first time, it is possible that the motor mounting plate requires a small cut-out to allow clearance of the new rotary union. (See pictures below). Belvac no longer supplies the Talco rotary union (Belvac part number C30405). If the C30405 part number is ordered, you will automatically receive the new rotary union part number **C10123**.

CC93RL DRIVE

CC93CL DRIVE

Belvac had used Talco Rotary Union C30405 for many years on all our CC trimmer series. Due to recent quality issues with the Talco unit that could not be resolved to our high standards, Belvac partnered with Rotary Systems to develop a unique and robust rotary union specific to Belvac's application. A Carbon Steel Construction with Hardened Shaft, Dual Sealed ball bearings, and Teflon seals make the new rotary union distinctive and durable. It has been successfully tested and implemented on all new Belvac CC Trimmers since April 2008. The new union has a new Belvac part number **C10123** and is a direct replacement to the Talco on the shaft.
